APN# 2061-001-025, 30800 Block Agoura Rd Section A-A' Static Global Stability

APN# 2061-001-025, 30800 Block Agoura Rd Section A-A' Pseudostatic Stability

This geotechnical update study was performed to review the current grading plan and observe the present site conditions for the proposed senior housing community at 30800 Agoura Road in Agoura Hills, California. The current grading plan by CC&R, Inc., which is the basis for our attached Plate 1, was changed significantly since our previous report (Gorian, 2003). The current plan shows development of two residential buildings with subterranean parking, a separate community building, associated surface improvements, and widening of Agoura Road.

Park at Ladyface Mountain Senior Apartments Project

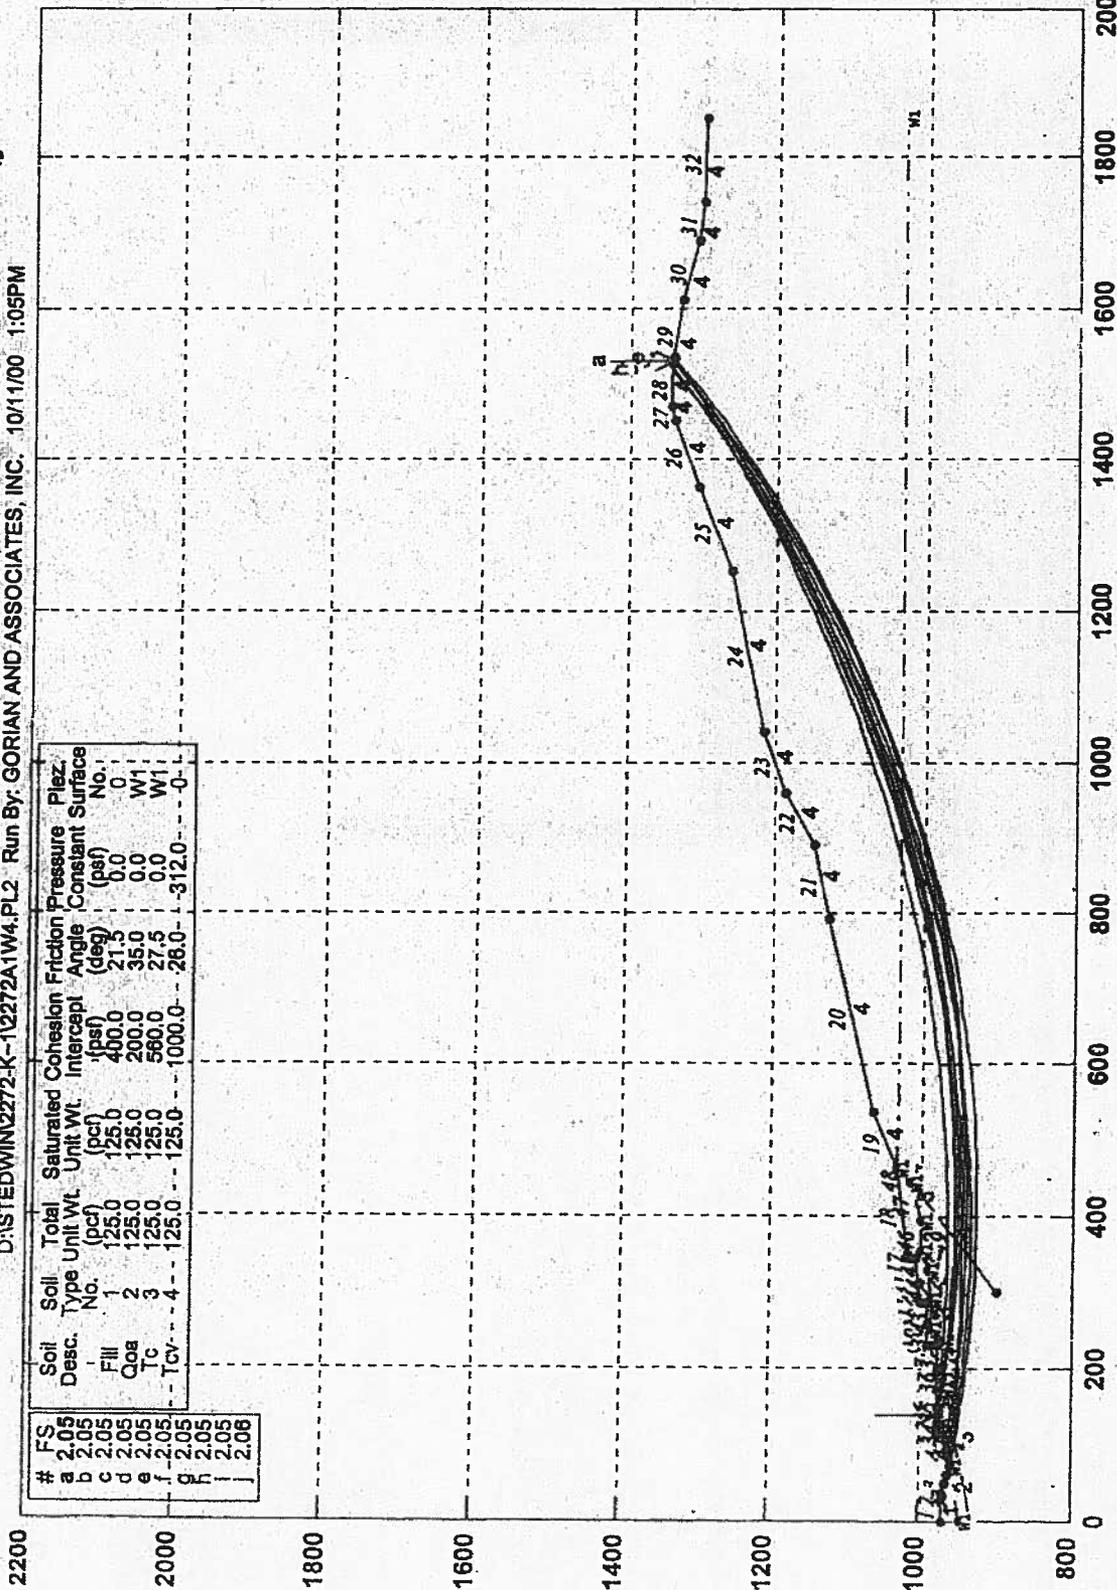
GSTABL7 FSmin=2.05
Safety Factors Are Calculated By The Modified Bishop Method

A Critical Failure Surface Searching Method, Using A Random Technique For Generating Circular Surfaces, Has Been Specified, 3000 Trial Surfaces Have Been Generated.

25.00 (ft) Line Segments Define Each Trial Failure Surface.

Following Are Displayed The Ten Most Critical Of The Trial Failure Surfaces Examined. They Are Ordered Most Critical First.

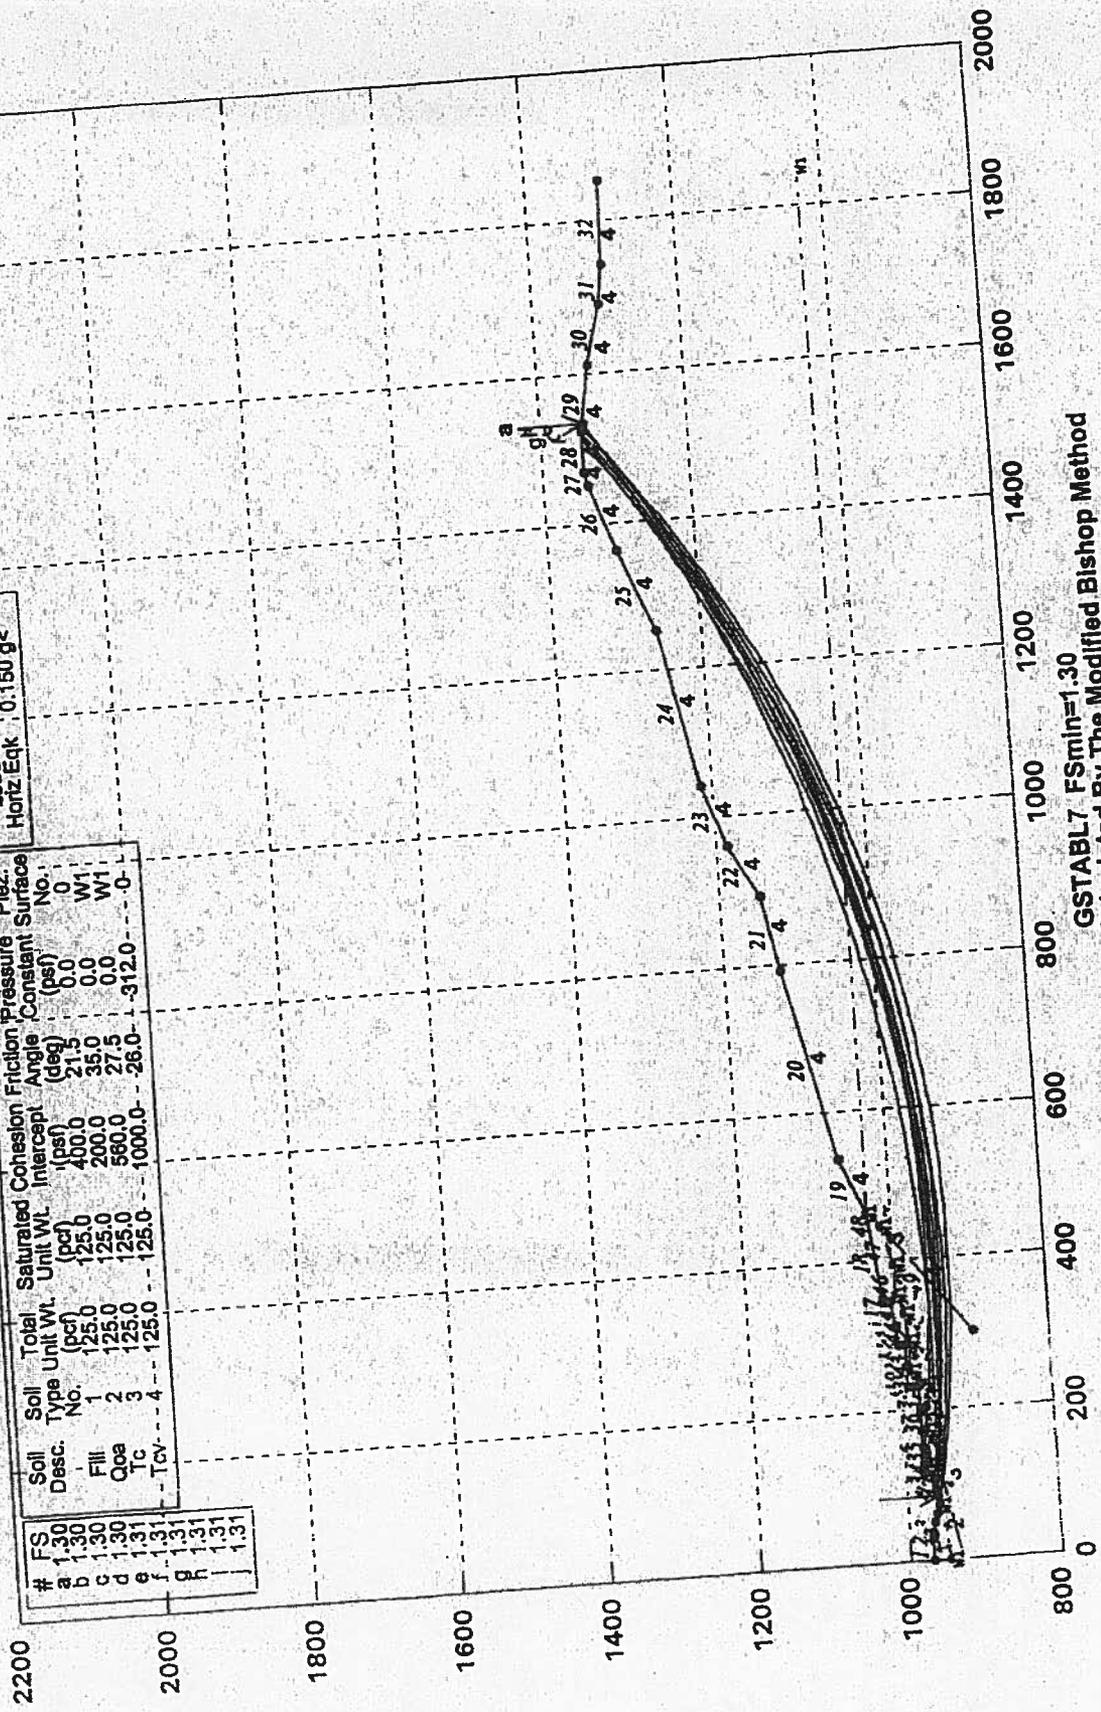
#	FS
a	1.30
b	1.30
c	1.30
d	1.31
e	1.31
f	1.31
g	1.31
h	1.31
i	1.31

GSTABL7 FSmin=1.30
Safety Factors Are Calculated By The Modified Bishop Method

A Critical Failure Surface Searching Method, Using A Random Technique For Generating Circular Surfaces, Has Been Specified. 2500 Trial Surfaces Have Been Generated.

10.00(ft) Line Segments Define Each Trial Failure Surface.

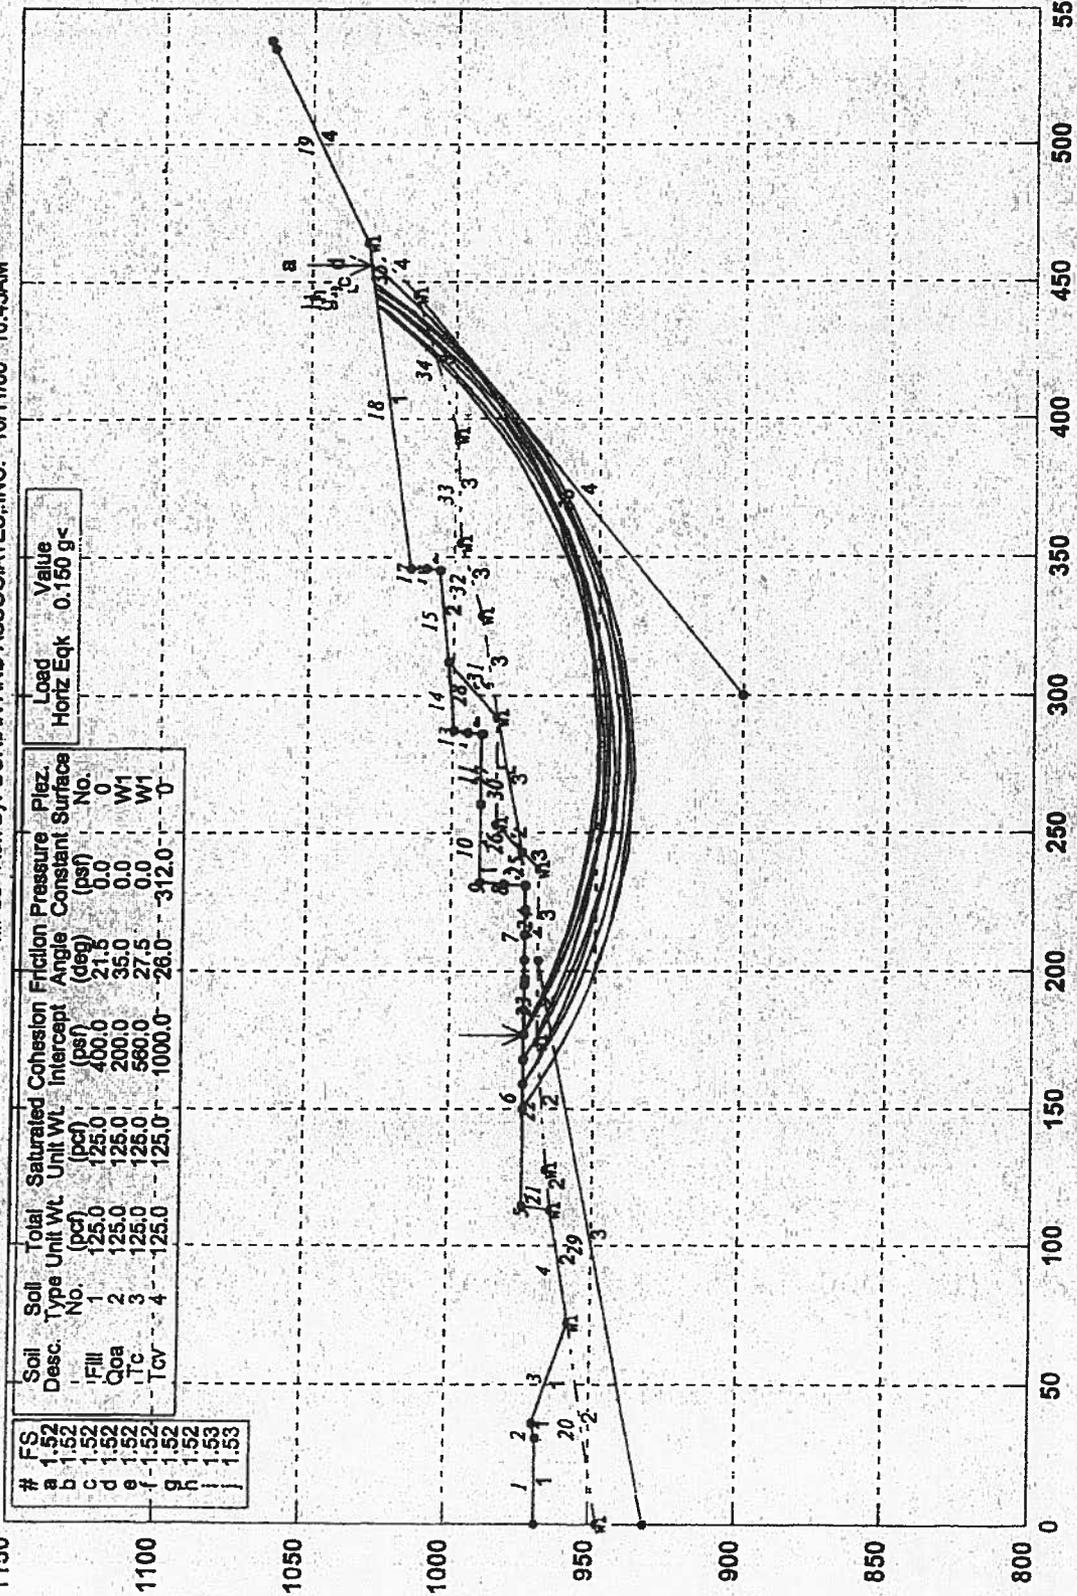
#	FS	Soil Desc.	Type No.	Total Unit Wt. (pcf)	Saturated Unit Wt. (pcf)	Cohesion (psf)	Friction Angle (deg)	Pressure Constant (psf)	Piez. Surface No.	Load Horiz Eqk	Value
a	1.52	Fill	1	125.0	125.0	400.0	21.5	0.0	0	0.150	g<
b	1.52	Clay	2	125.0	125.0	200.0	35.0	0.0	W1		
c	1.52	TC	3	125.0	125.0	580.0	27.5	0.0	W1		
d	1.52	TC	4	125.0	125.0	1000.0	26.0	-312.0	0		
e	1.52										
f	1.52										
g	1.52										
h	1.53										
i	1.53

GSTABL7 FSmin=1.52

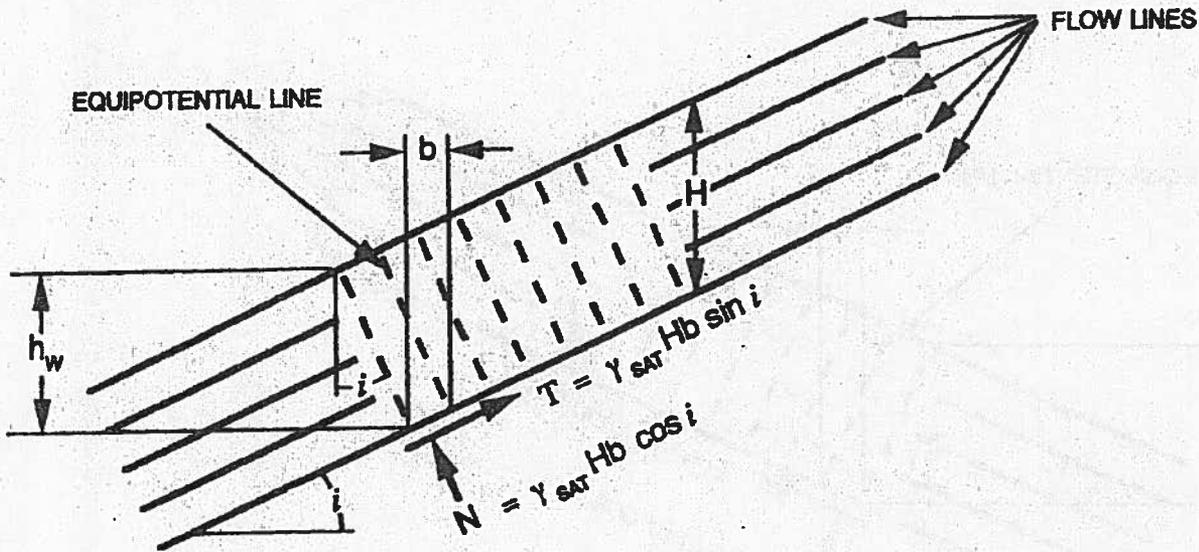
$$T = \frac{T}{b/\cos i} \frac{\gamma_{SAT} H \sin i \cos i}{b/\cos i} = \gamma_{SAT} H \sin i \cos i = \text{TANGENTIAL STRESS}$$

$$\sigma = \frac{N}{b/\cos i} - h_w \gamma_w = \gamma_{SAT} H \cos^2 i - h_w \gamma_w : \gamma' H \cos^2 i = \text{NORMAL STRESS}$$

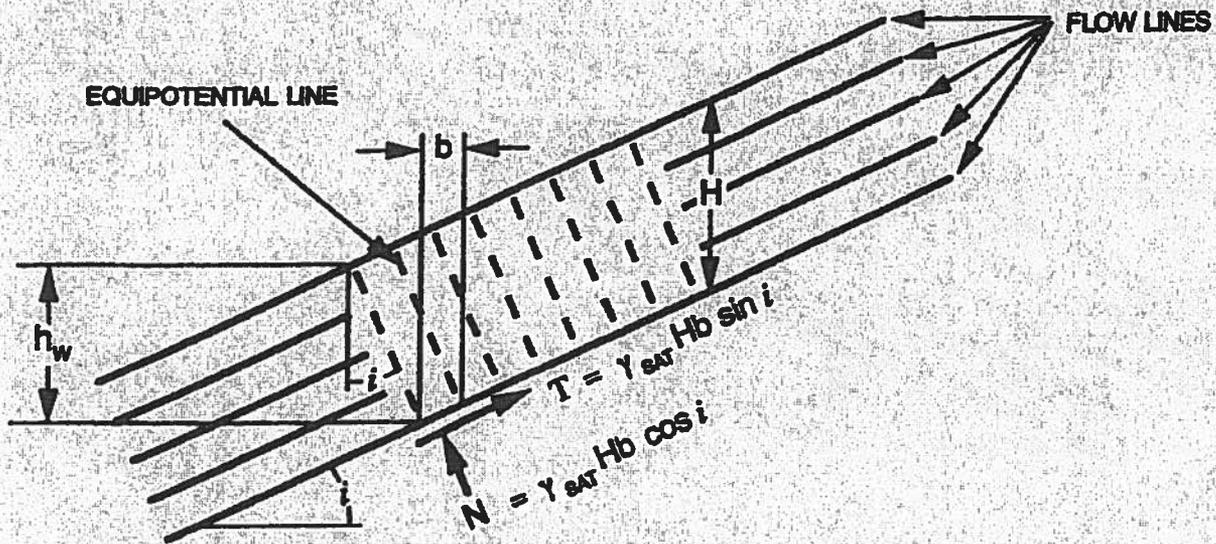
$$T = \frac{T}{b/\cos i} \frac{\gamma_{SAT} H \sin i \cos i}{b/\cos i} = \gamma_{SAT} H \sin i \cos i = \text{TANGENTIAL STRESS}$$

$$\sigma = \frac{N}{b/\cos i} - h_w \gamma_w = \gamma_{SAT} H \cos^2 i - h_w \gamma_w : \gamma' H \cos^2 i = \text{NORMAL STRESS}$$

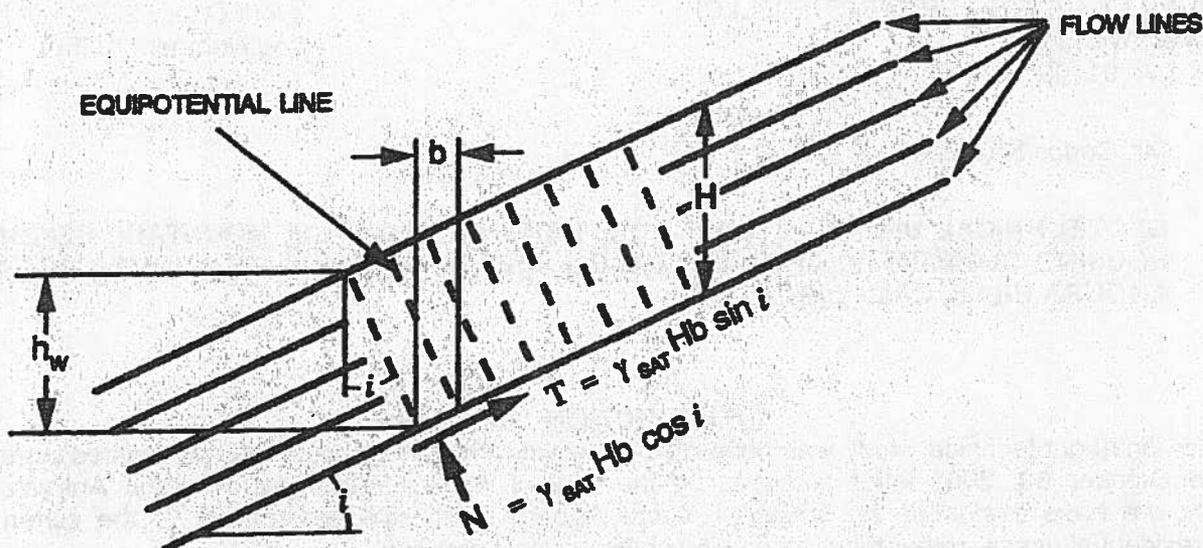
$$T = \frac{T}{b/\cos i} \frac{\gamma_{SAT} H \sin i \cos i}{b/\cos i} = \gamma_{SAT} H \sin i \cos i = \text{TANGENTIAL STRESS}$$

$$\sigma = \frac{N}{b/\cos i} - h_w \gamma_w = \gamma_{SAT} H \cos^2 i - h_w \gamma_w : \gamma' H \cos^2 i = \text{NORMAL STRESS}$$
